# Grand Traverse Pavilions

## COTTAGES FACILITY MASTER PLAN

Evergreen, Hawthorn & Willow Cottages

February 2025

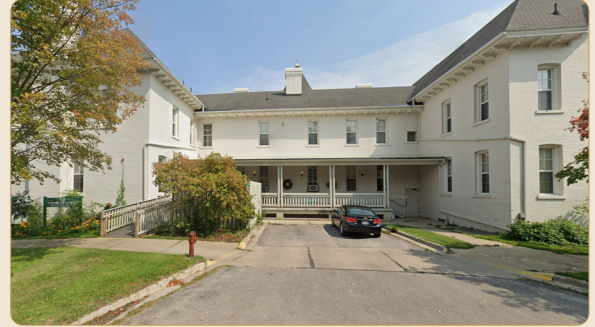
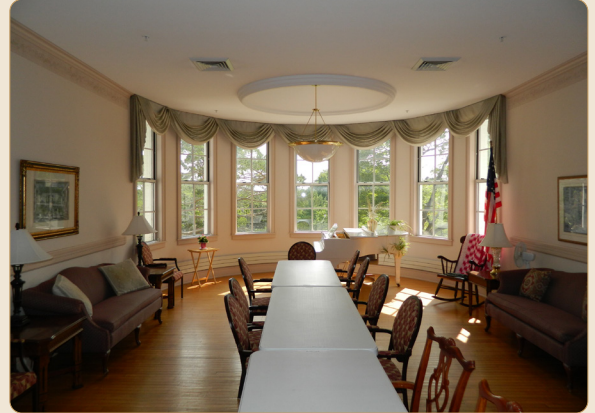
##### Terrace

- Convert obsolete tub/spa room into a staff breakroom.
- Convert beauty salon into new laundry room.
- Renovate rooms with water damage.
- Provide water proofing solution to prevent water infiltration.

##### First Floor

- Expand and renovate existing kitchen.
- New casework serving counter for dining room.
- Convert existing staff break room into toilet rooms.

Second Floor—No changes

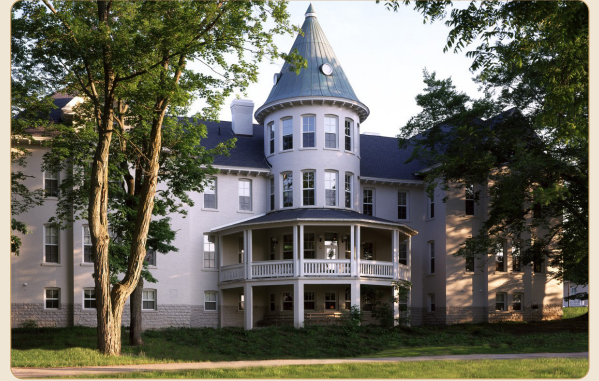
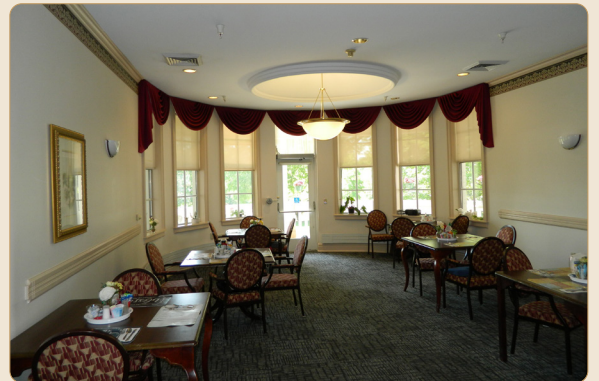
##### Terrace

- Renovate beauty/barber shop.
- Renovate staff break room.

##### First Floor

- Renovate warming kitchen.
- New casework serving counter for dining room.
- Renovate exterior stairs, ramps, and decks.

##### Second Floor—No Change

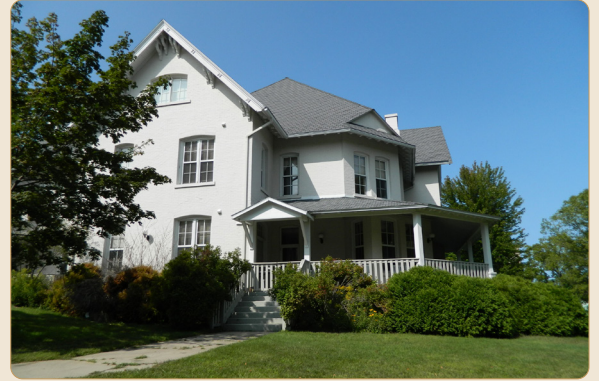
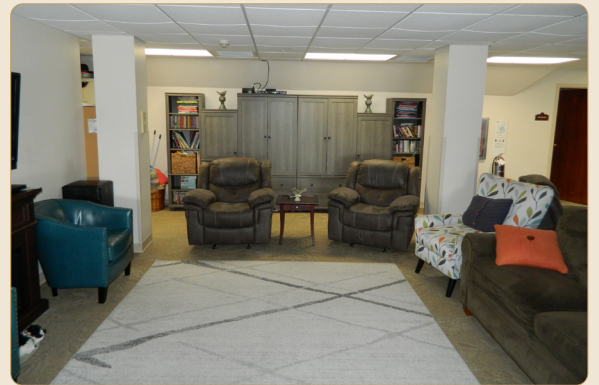
Terrace

- Renovate existing staff break room into a laundry room.
- Renovate existing maintenance room into a new staff break room with a window and an additional, functional maintenance area.

First Floor

- Renovate shower room.
- Renovate nurse office.
- Renovate and expand kitchen; delete room 110.
- Expand lounge space; delete room 100.
- Flip function of dining room and lounge spaces.
- Renovate existing stairs, ramps, and decks.

Second Floor

- Renovate shower room.
- Laundry moves to Terrace Level.
